Manhole Inspection Summary

Manhole # S23KK1013MH

Location Address: **4309 BUCHANAN AVE**

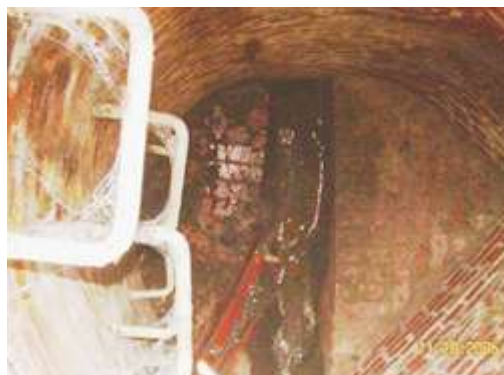
Top View

Bench and Channel debris.

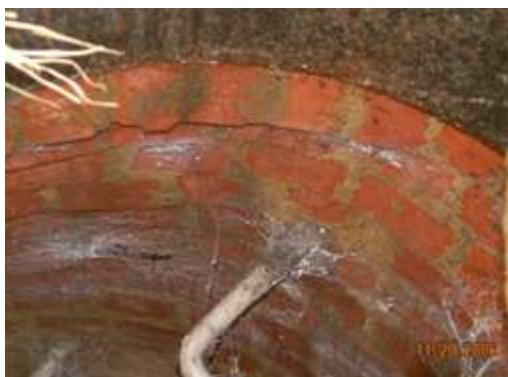
Defect

☒ **Leaks**

Infiltration: ☐ None ☒ **Joint** ☐ Cracks ☐ Mortar ☐ Roots ☐ Wall

Frame leaks. Adjustment infiltration.

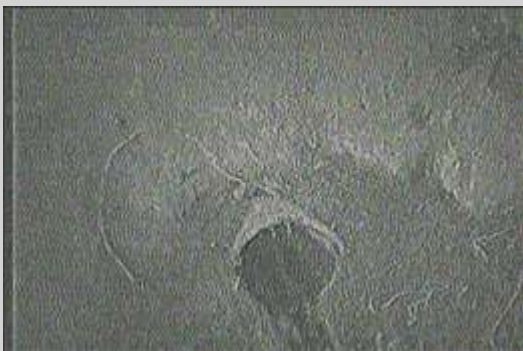
4 in. Circular Gravity Sewer Pipe In @ 6 O'Clock

Barrel root intrusion and infiltration. Channel root intrusion.

Infiltration: **None** Pipe Seal Cond: **Roots**

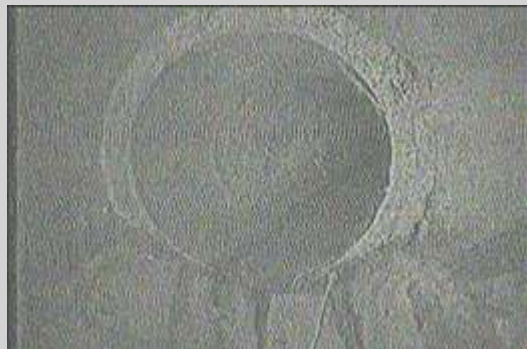
8 in. Circular Gravity Sewer

Pipe Seal Cond: **Roots**
